3.0 PHYSICAL ANALYSIS

3.1 GENERAL DESCRIPTION OF GOAT ISLAND

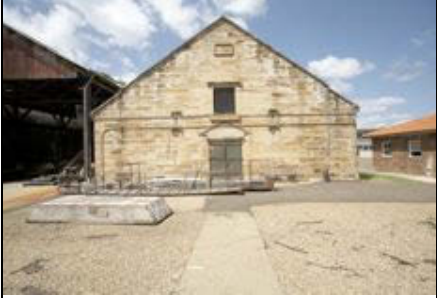
Item No	Date	Name	Level of intactness	Condition
Aboriginal Use and Contact				
-	-	-	-	-
Colonial Period				
15*	1836	The Queen's Magazine	Largely intact	Good/fair

<p>The Queen's Magazine is a rectangular shaped building of block sandstone construction with a gabled slate roof. An interior stone vault is supported by massive buttresses along the side walls. The main entrance doors, located on the north elevation, are original timber, sheeted over with copper on the outside. Directly above the entrance is a hood mould integral with the stone lintel. Above the hood mould are two sloping chases with two rectangular sockets at their outer ends. A broad sandstone block protrudes from the adjacent stonework directly above the pediment forming the sill of the upper level opening. The upper level shutters are screened by a grill of fine copper wires within a weathered timber frame and the opening has a hood mould above similar to that over the entry doors. Above this is a rectangular date plaque toward the apex of the gable. Two ventilation assemblies consisting of a hexagonal and single vertical slit, each with hood mould, are located symmetrically either side of the main doors. There are two rectangular openings in the wall close to ground level. Conduiting runs across the face of the north elevation, and on the west corner are a series of corroded metal fixings.</p> <p>The east and west elevations consist of a series of sandstone buttresses forming evenly spaced bays. At the centre of each bay are hexagonal and vertical slit with hood moulds over, matching those on the gabled elevations. Toward the base of the wall within each bay is an opening in the stonework. On the south wall (inside the corrugated iron shed one of these openings has a bronze grill). An upper opening and ventilation motifs similar to the north elevation are evident on the south elevation, above the roof the shed.</p> <p>The roof to the magazine is covered with weathered Welsh slates which are randomly scarred, quite extensively toward the ridge. The lower portion of the eastern roof of the gable is a darker colour than the rest of that roof. The ridge capping is lead and appears to be in good order. Copings to the gable ends and buttresses are broad stone cappings, some of which are weathered.</p>

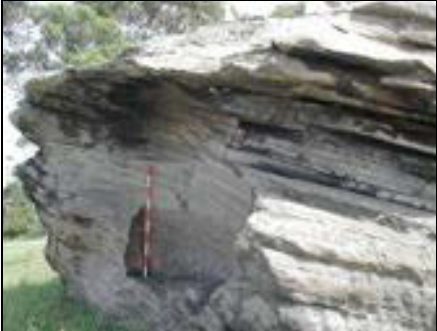
<p>A large rock outcrop adjacent to the path on the southern side of the Island contains a cut shelf measuring 1.5m long and 300mm-500mm wide and 600mm above the ground surface. Evidence of three attachments to the rock and a number of sandstone blocks in the ground in front of the shelf.</p> <p>A recalcitrant convict, Charles "Bony" Anderson, was chained to a rock in Sydney Harbour for several weeks before being transported to Norfolk Island. This place has been associated with his incarceration, although no descriptions of the exact location are known.</p>

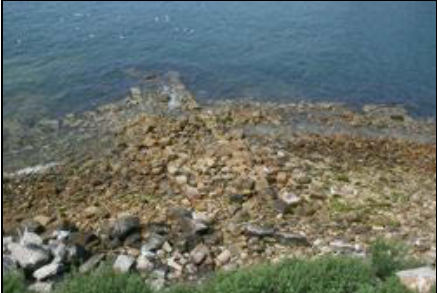
Item No	Date	Name	Level of intactness	Condition
66	1835c	Stone jetty remains	A ruin below high water mark	Ruin

<p>Located on the south western end of the Island, the jetty is almost completely destroyed although still well defined at both high and low tide. The 1985 survey identified at least three courses still standing while it appears that only one course now survives intact, the rest is rubble. It measures 16m x 2.5m and blocks have been robbed to create the swimming pool on the western side.</p> <p>Several authors suggest a range of dates for construction between 1840-1899. Hosty (HLA: 17) states the stone jetty dates between 1839-42 but it is not on plans dating to 1844. The HLA phasing plan places it post 1860 and Thorp dates it to phase three 1840-1899 and it does not occur on plan in Kerr's report until 1891.</p> <p>There is no evidence of access to the jetty.</p>	
67*	1830s	Remains of Blacksmith's Shop	Archaeological site, markings on rock face remaining	Good/fair

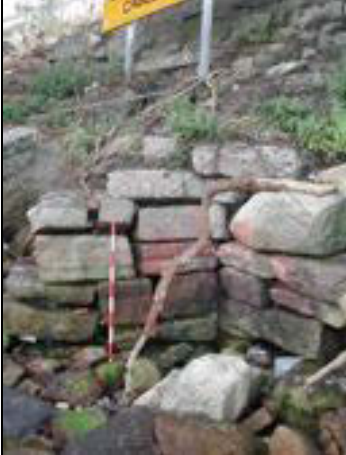
Item No	Date	Name	Level of intactness	Condition
92	1830s	Stone structure on shore	Archaeological site	Poor

Located on the water's edge to the south of the kitchen and outbuildings. Consists of two stone walls 7 courses high (approx 1.2m) which meet at right angles at the base of the retaining wall and adjacent to the submarine cable. Large pieces of slate and numerous artifacts are located here as well. No documented evidence for its function.	
94*	1838-1891	Privy and outbuildings site	Archaeological site, no visible remains	n/a

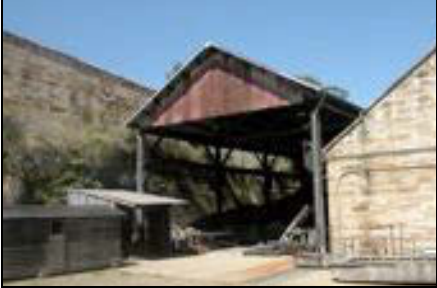
Item No	Date	Name	Level of intactness	Condition
Maritime Period: Sydney Harbour Trust Phase				
16*	1925-1928	The Scow shed	Largely intact, recent removal of parts of roof and drainage	Fair/poor

<p>The Scow Shed is a galvanised iron roofed timber framed structure between the Queens Magazine and the quarry face. It is an elongated single storey open structure with an overhead moveable crane supported on a steel girder track. It is constructed with a timber post and trussed roof. The ground finish has a bituminous coating over fill. The rear wall is clad in corrugated iron over a light timber frame. Recently the west side has been excavated and the roof removed to improve drainage to the magazine building.</p>		
22*	1930c	Amenities building	Reasonably intact	Fair/poor

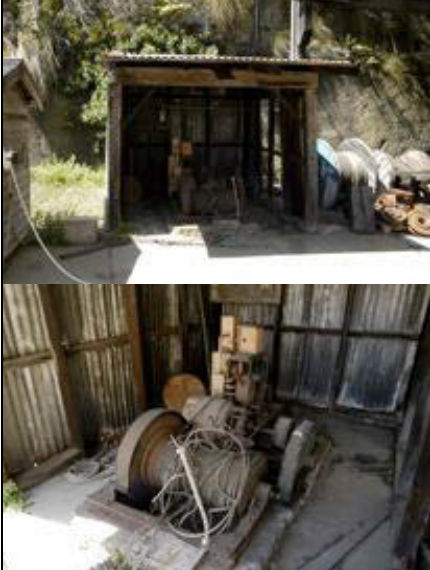
Item No	Date	Name	Level of intactness	Condition	
96	1925	Winch House	Largely intact	Fair/poor

A simple timber framed corrugated iron clad skillion roofed shed located immediately north of the Scow Shed (16), housing the winch mechanism that powered the rope line, moving vehicles on the rail tracks from the wharf up the gentle slope to the magazine area. While the tracks have been removed or covered over, the winch and its housing and shed remain.		
136	c.1930s	Canary Island Date Palm (<i>Phoenix canariensis</i>)	Mature	n/a

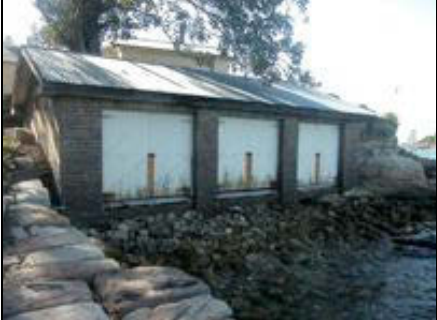
This is a utilitarian and simple rectangular brick building with a gabled corrugated iron roof, and three pairs of timber doors facing south opening onto the water's edge. The sliprails have been removed and are stacked nearby. The building is cut into the shoreline which involved the partial demolition of an early lime kiln. The foundations are washing away at the southeast corner and the front edge of the building is becoming undermined by wave action.

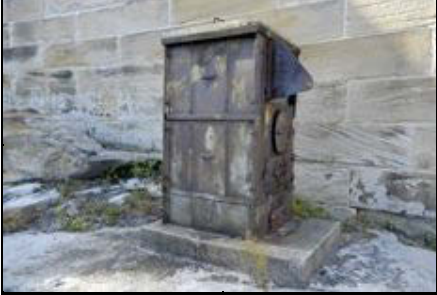
Item No	Date	Name	Level of intactness	Condition
90	1960c	Incinerator	Intact	Poor

<p>A standard c1960 prefabricated incinerator inserted between the rear of the stores building and the perimeter wall on a convenient rock outcrop. It is utilitarian in nature.</p>		
107	1955-1962	Remains former mess room slab	Archaeological site, slab remains visible	Fair

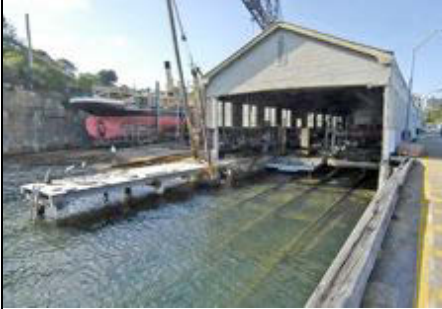
Item No	Date	Name	Level of intactness	Condition
Pre Contact Period				
-	-	-	-	-
Colonial Period				
-	-	-	-	
Maritime Period: Sydney Harbour Trust Phase				
113*	1926	Slipway	Reasonably intact	Fair

The first slipway to be constructed by the SHT remains adjacent to the broadside wharf and now partially covered by workshop buildings. Cut into the base rock along the shoreline it did not require excavation of the cliff face as the later slips required. It comprises 2 sets of iron rails fixed to the sloping rock base.		
122	1926	Remains of railway	Archaeological Site	Poor

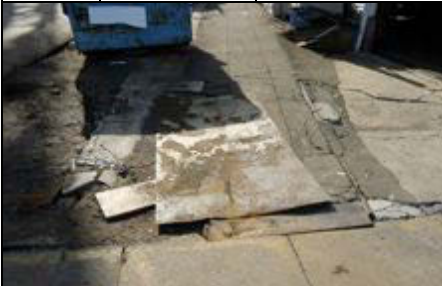
Remains of the Harbour Trust rail system that operated on the wharves and within the magazine precinct, sections of rail and possibly turntables remain under the asphaltic finish. The alignment of the former tracks and the winch house are strong visual reminders of this phase of use. The tracks on the wharves were removed with reconstruction and other sections appear to have been removed for other construction.

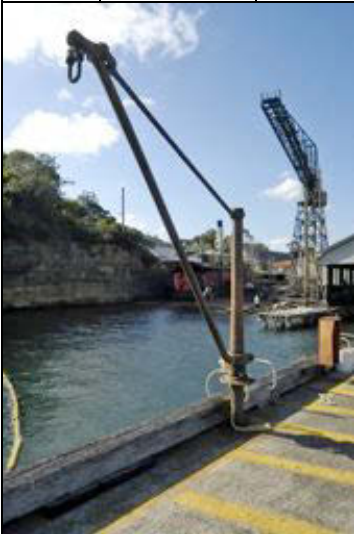
<p>An early hand operated jib crane apparently added to the 1945 wharf. Its former location and use (it is significantly older than the wharf on which it was located) and history are not known. The crane is now beneath wharf debris on the floor of the harbour after the collapse of this section of the broadside wharf.</p>	
121	1945c	Jib Crane	Reasonably intact	Poor

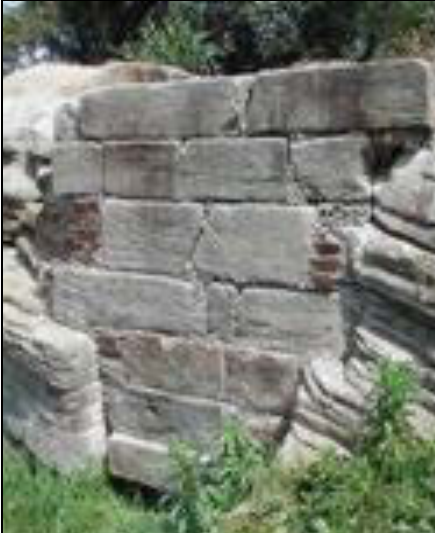
<p>The lime kiln is located just to the east of Anderson's couch. It is cylindrical, overgrown and silted up, measuring 2 m diameter and is 2.2 m deep. While it is constructed partly of ashlar blocks and brick, much of the structure is cut into the natural contours of the rock outcrop. Slag is used in the mortar and the kiln contains associated ash and lime deposits and evidence of high temperature burning.</p> <p>Lime kilns are generally temporary structures, built near the site where lime was required. This example would have been oriented over the water to the south east to ensure that the opening in its base provided an accelerated updraft to guarantee that the shell was well burnt. While the lime kiln is small and primitive, it is consistent with penal establishments of the 1830s (Kerr 1987).</p> <p>Mortar on the top stones suggest several courses may be missing and several slots cut into the top of the upper-most stones suggest a roof or platform was built over the top.</p> <p>Much of the surrounding stone has been quarried or shaped and four metal pins have been mortared into small holes cut into the southern face of the rock.</p>

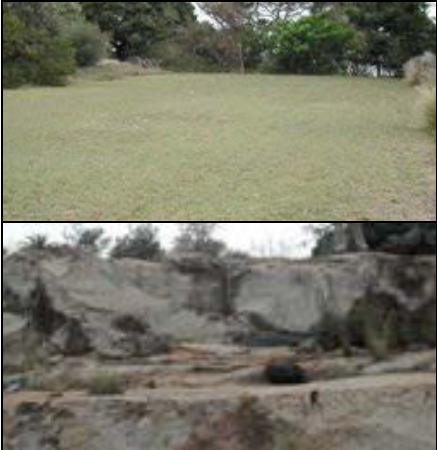
Item No	Date	Name	Level of intactness	Condition
Maritime Period: MSB Phase				
15b	1941	Tennis court foundation	Foundation intact, no longer in use	Deteriorated Poor
15c	1941	Tennis court pavilion site	Archaeological site, no extant evidence	n/a

Constructed in 1941 on what was probably a reasonably flat area to the south of the magazine precinct, the tennis court was the first of a number of recreational facilities constructed for the inhabitants of the Island. The court is assembled on fill and cut into the bedrock on the north eastern side, retaining evidence of modern explosives to remove the rock. A dry stone retaining wall supports the southern and part of the western side of the court. The bitumen surface is almost completely overgrown with only patchy evidence of the white lines intact. The 1985 survey identified a single net post still standing, however this no longer survives. The site of the pavilion was to the west of the tennis court, but apart from stone stairs cut in the rock platform, nothing of this building survives. 8 metres of sandstone block footings from an earlier structure (91) are visible on the western side of the court running under the tennis court at a different alignment.
